Innovative shaft inspection system for the Gotthard Base Tunnel

Martina Puglia, Peter Spohn & Klaus Wachter*
Amberg Infra 7D, Regensdorf, Switzerland

ABSTRACT: Amberg was commissioned by the Swiss Federal Railways SBB to develop a measurement system and execute an inspection of the 800 m deep Sedrun shaft B at the Gotthard Base Tunnel. A special shaft module equipped with multiple sensors was built to acquire a reliable data base. The inspection and condition assessment were performed based on this data using an in-house inspection and data management platform. This paper presents the innovative measurement system developed and highlights the challenges encountered during this project.

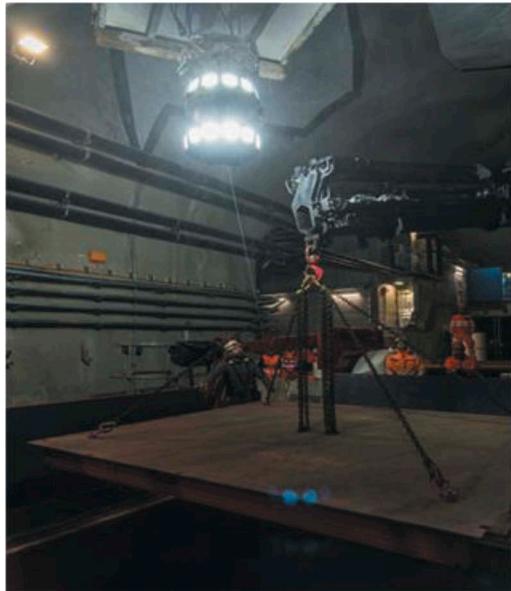
Figure 3. MCIS before entering the shaft B.

The data acquisition for inspecting the shaft B occurred on the 11th and 12th of July 2021, around midnight when a free slot in the train traffic schedule was available. In coordination with Amberg, the SBB provided a special crane with over 800 m of rope and a case for the MCIS installation. Before the measurement, everything was installed and tested on-site. Just before entering the shaft from its top, the MCIS with all its subsystems was initiated, and autonomous data recording commenced.

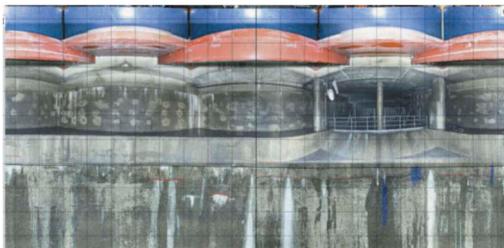
Figure 5. 360° panoramic image of the shaft surface.

The camera data was also post-processed in a similar manner to the scan data. Photo corrections, such as exposure, vignetting, and white balance adjustments, were applied to achieve homogeneous pictures of the shaft surface. Since all photos were taken simultaneously from each camera in sets of six, 360° panoramic images were created using photo-stitching techniques. The final step involved vertically sorting and cropping each panorama picture to generate a complete picture of the vertical shaft surface. Figure 5 below shows the 360° panoramic image at the shaft head: The blue objects are the safety barrier which were installed around the open shaft. Right below the red shaft cover is visible. Under the shaft cover a chamber is visible on the right-hand side. This is the “exhaust” that leads the air to the turbines. The lower part of the images shows the shaft surface with marked defects in blue and red.
